**The Long Duration Exposure Facility (LDEF)  
Photographic Survey Special Publication**

# Heavy Ions In Space (M-0001)

Heavy Ions In Space (M-0001)

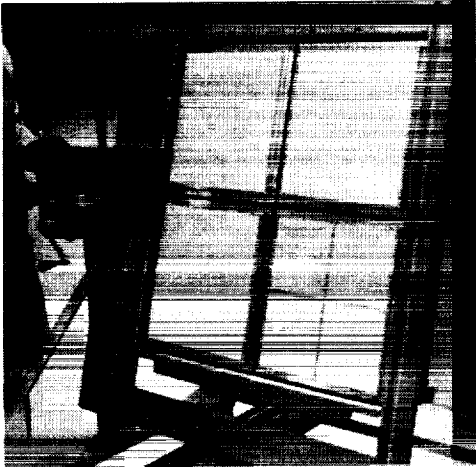
Figure 1

Photo No.: KSC-384C-331/6  
Photo credit: KSC 1/24/84  
Digitized from dup. neg. L84-7187  
Location: KSC SAEF II  
Subject: Tray H12  
Experiment: M-0001; Heavy Ions In Space

### Preflight (Figure 1)

The four modules including the one subdivided into quadrants are shown mounted in a 4-inch deep space facing end tray. The exposed surface of each detector is Chemglaze II A-276 white paint on the aluminized Kapton top layer of a multilayer thermal blanket. The frame around each of the four modules is a "Z" shaped aluminum structure covered with a silvered teflon film secured with 3M-Y966 acrylic tape. The 3M-Y966 tape on a silvered teflon film is also used to attach the multilayer thermal blankets to the module frames.
